Survey Report On

**Tirlot,
Rousay,
Orkney,
KW17 2PR.**

Date of inspection: 1st April 2025.

Prepared by: Christopher Park, M.R.I.C.S.,
Chartered Surveyor,
R.I.C.S. Registered Valuer.

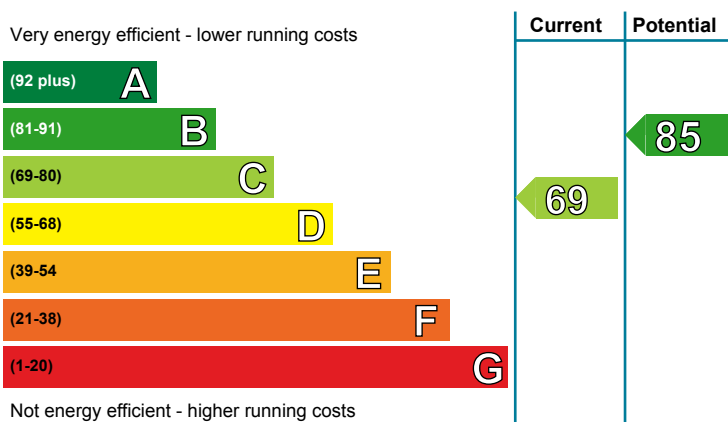
Energy Efficiency Rating

This graph shows the current efficiency of your home, taking into account both energy efficiency and fuel costs. The higher this rating, the lower your fuel bills are likely to be.

Your current rating is **band C (69)**. The average rating for EPCs in Scotland is **band D (61)**.

The potential rating shows the effect of undertaking all of the improvement measures listed within your recommendations report.

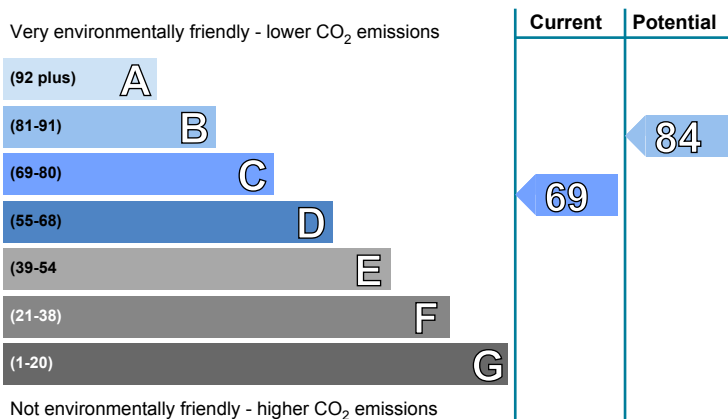
Environmental Impact (CO₂) Rating

This graph shows the effect of your home on the environment in terms of carbon dioxide (CO₂) emissions. The higher the rating, the less impact it has on the environment.
